# UNDERWATER BRIDGE INSPECTION REPORT

STRUCTURE NO. 73514

SAINT GERMAIN STREET (MSAS NO. 128)

MISSISSIPPI RIVER

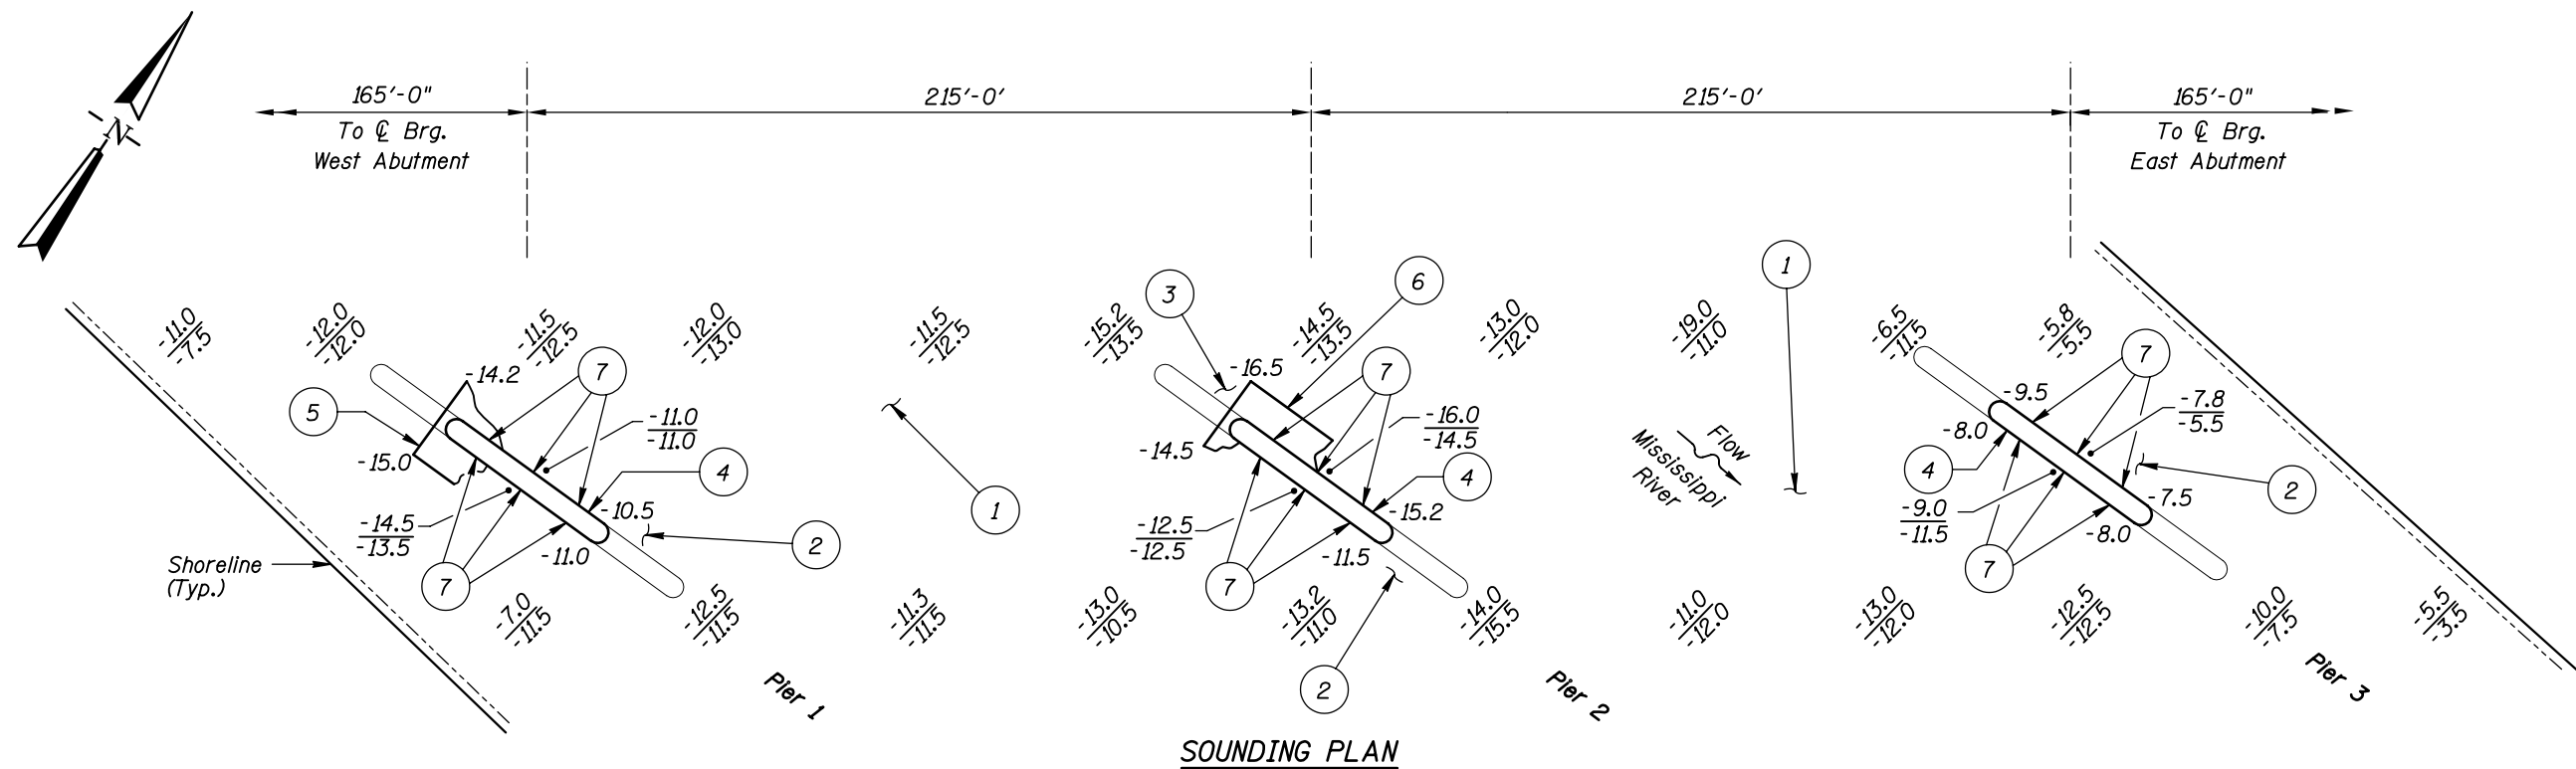
**INSPECTION AND SOUNDING PLAN**

- 1 The channel bottom material consisted of sand and small diameter rock with a maximum probe rod penetration of 3 inches.
- 2 The channel bottom material consisted of 12-to 18-inch-diameter riprap with sand infilling and no probe rod penetration.

- 3 The channel bottom material consisted of 1-foot-diameter riprap with sand and gravel infilling and up to 4 inches of probe rod penetration.
- 4 Light scaling with a maximum penetration of 1/8 inch was observed on all piers from 1 foot above to 1 foot below the waterline.

- 5 Footing exposure was detected, extending 5 feet across the upstream face, around the nose, and for approximately 10 feet along the south side of the pier face with a maximum vertical face exposure of 1 foot at the upstream end.

- 6 Footing exposure was detected, extending approximately 6 feet across the upstream face and approximately halfway down the north face of the pier with a maximum vertical face exposure of 1 foot at the upstream end.

- 7 Steel I-beams were observed extending through the pier and cut flush with the pier shaft faces at 4 feet and 10 feet below the waterline.

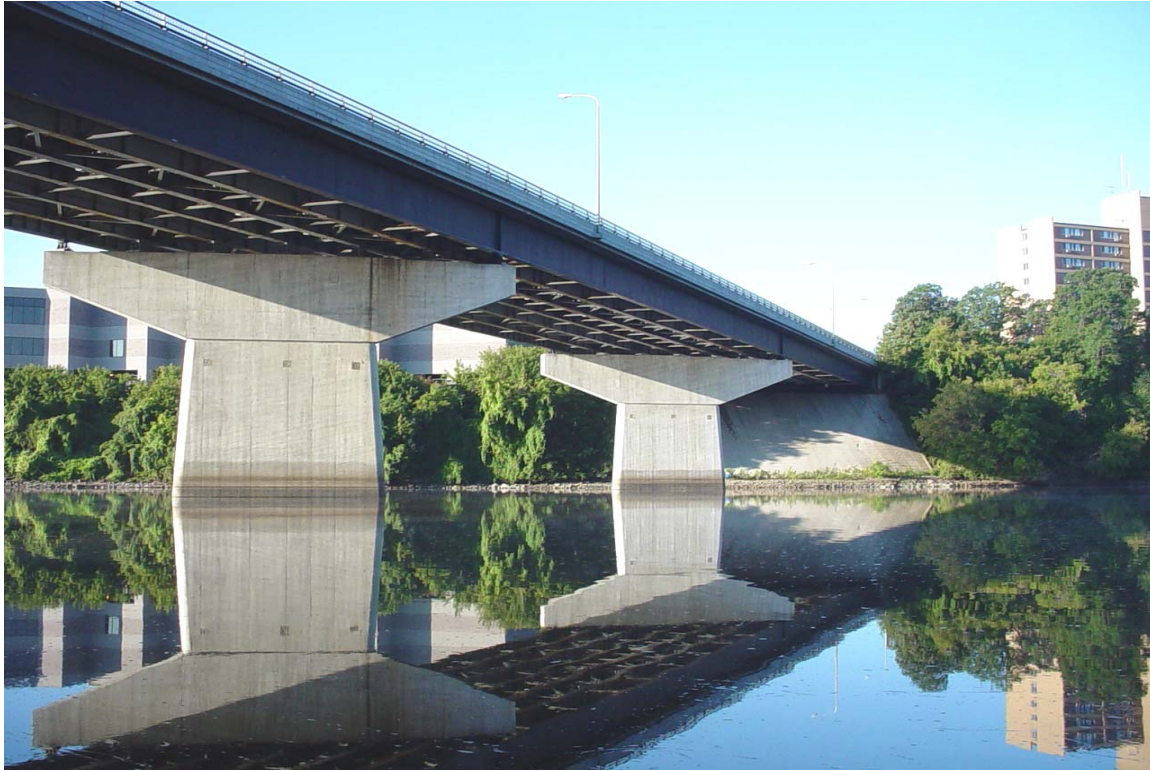
Photograph 1. Overall View of Piers 1 and 2, Looking South.

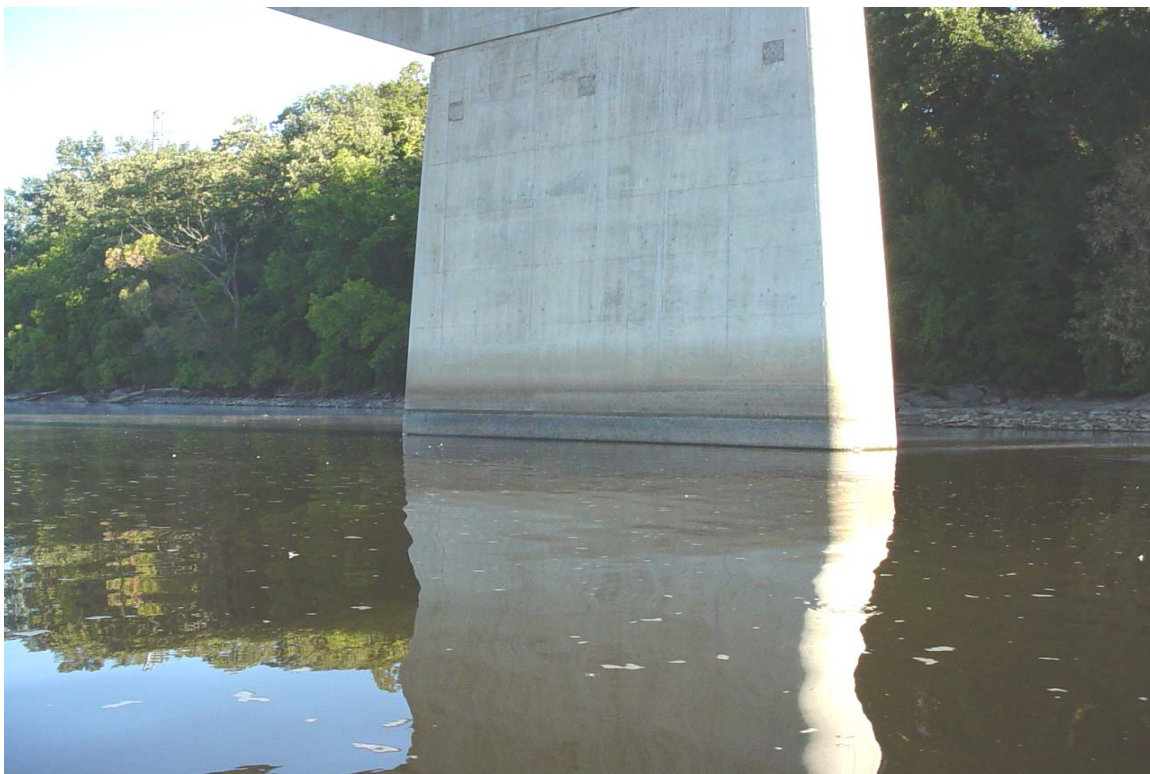
Photograph 2. View of Pier 3, Looking North.

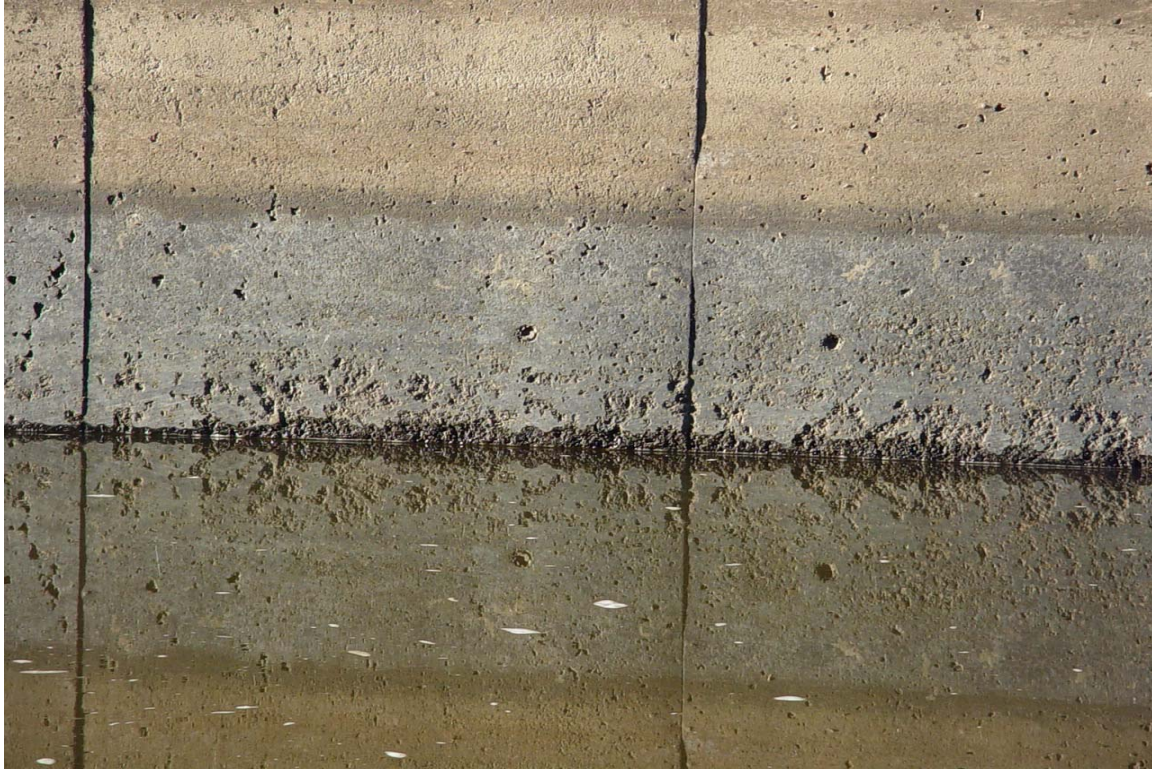
Photograph 3. Close up View of Typical Light Scaling Mid Section of Pier 3 at the Waterline, Looking South.
